Categorical Exclusion Appendix E Red Flag Investigation & Hazardous Materials

- To: Site Assessment & Management Environmental Policy Office- Environmental Services Division Indiana Department of Transportation 100 N Senate Avenue, Room N642 Indianapolis, IN 46204
- From: Ruth Hook 3502 Woodview Trace, Suite 150 Indianapolis, IN <u>rhook@lochgroup.com</u>
- Re: RED FLAG INVESTIGATION Des. No. 1702837, Local Project Bridge Rehabilitation Project East LaPorte Street Foot Bridge over Yellow River Marshall County, Indiana

Red Flag Investigation - Site Location East LaPorte Street Foot Bridge over Yellow River Des. No. 1702837, Bridge Rehabilitation Marshall County, Indiana

DESIGNATION NUMBER: 1702837 CONTRACT NUMBER: R-41181

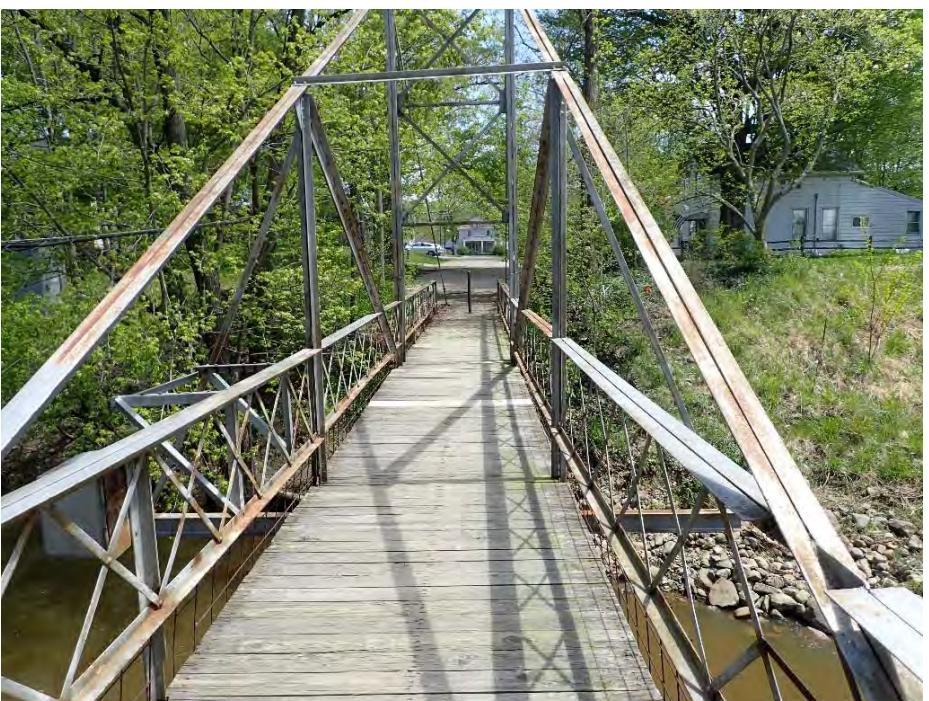
- 3. <u>Surface Condition</u>. The existing timber decking shows wear and some planks have been recently replaced. (Photo 2)
    - 4. <u>Underside Condition</u>. The underside of the timber decking is wet and molding in some locations. The moisture absorbed by the deck is accelerating the corrosion in the stringers and floorbeams supporting it. (Photo 3)

Photo 2: Bridge Deck and Superstructure (Looking east from the midspan of the bridge)

<u>Bridge Deck:</u> The existing timber deck will be replaced with new timber decking or composite decking. The existing timber decking has likely been replaced several times throughout the lifespan of the structure and it is not historic. Benefits of using a composite decking is that it does not fade over time, does not deteriorate like timber decks, and does not absorb water, which has been the cause of stringer and floorbeam deterioration.

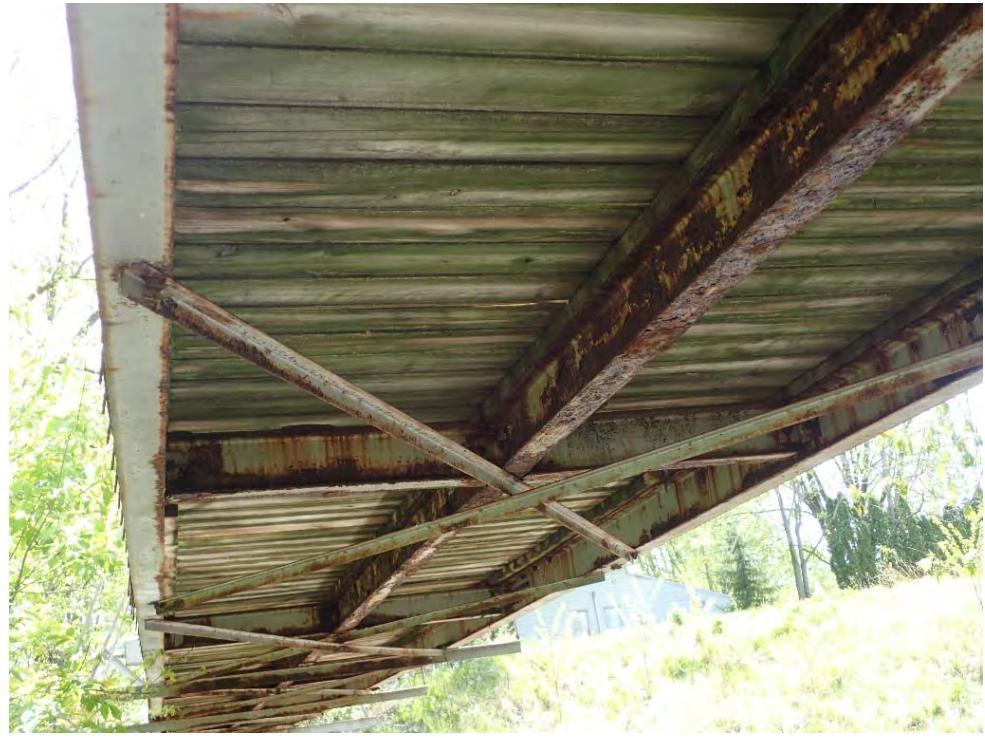
Photo 3: Underside of Bridge Deck (Looking east from the west bank)

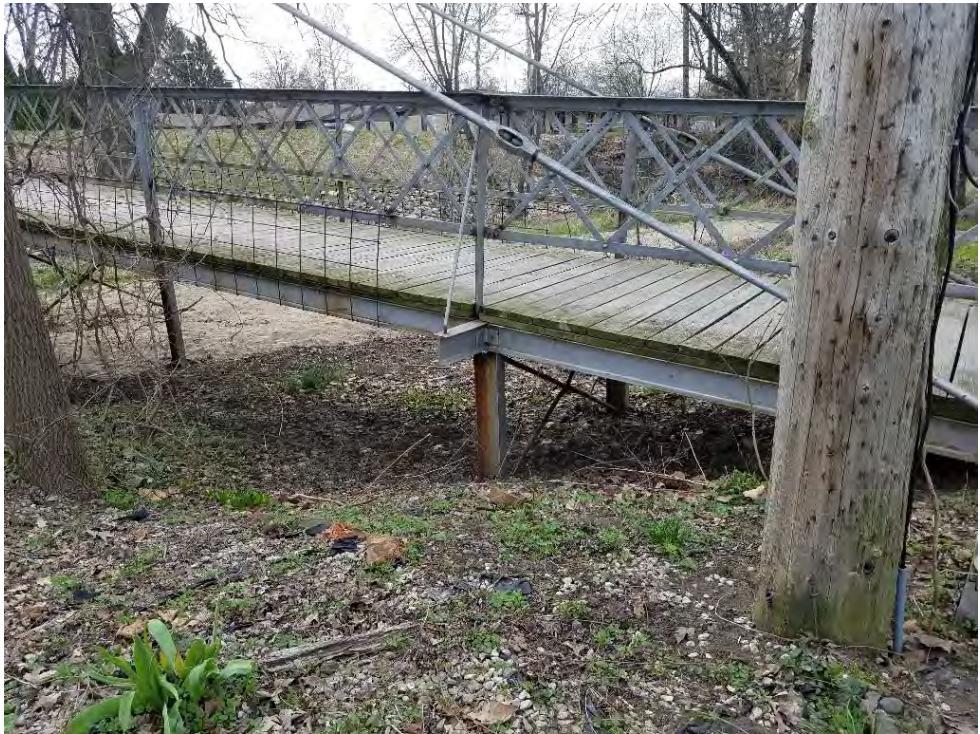
- 6. <u>Drainage</u>. Water drains through the gaps between the timber planks, and is not channeled or routed.
- 7. <u>Bridge Railing</u>. The existing bridge railing is steel, and it is in fair condition. The height of the railing from the top of the bridge deck is 42 inches, which meets the AASHTO requirements in Section 13.7.3.2. The railing does not meet the maximum gap spacing requirements described in AASHTO Section 13.7.3.2. Wire mesh has been added to the bottom of the railing to add some level of additional protection for children and small pets. (Photo 4)

Photo 4: Bridge Pedestrian Railing (Looking south from the northwest corner of the bridge)

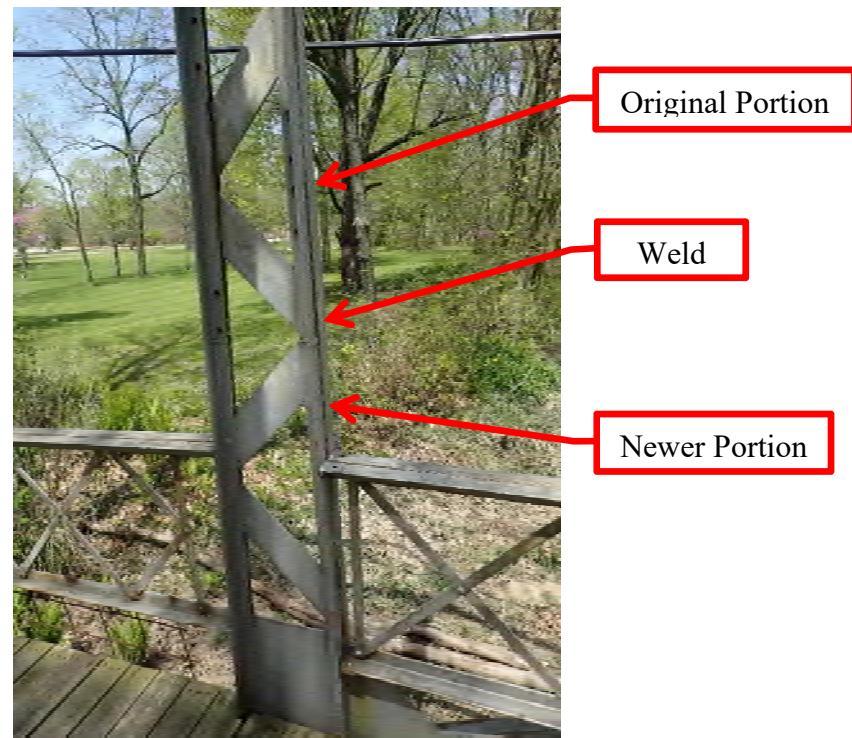
- Lateral bracing has been added to the superstructure. (Photo 7)
    - Portions of the main towers have been replaced. (Photo 5)
    - The floorbeams and stringers underneath the bridge deck have likely been previously replaced.

Photo 5: The bottom portion of the main tower has been replaced *(Looking north from the bridge deck at the west pier)*

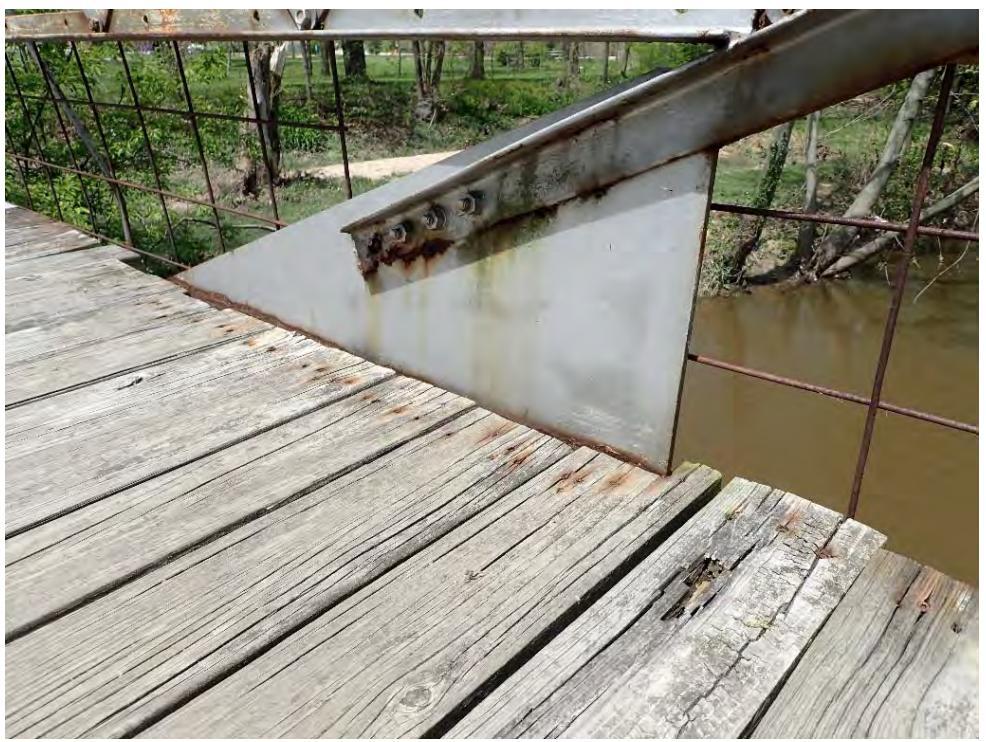
- Some rivets and bolts are missing in the superstructure connections. (Photo 6)
- 4. <u>Fracture-Critical Member or Low-Fatigue-Life Details</u>. The main cables and truss elements of the bridge are fracture critical. Connections of these members are gusset plates for the angle members, and pin connections for the cables. The gusset plates are originally connected with rivets, though some of the rivets have been replaced with bolts in previous repairs. These fracture critical members are in fair condition, and they show minor rusting. No cracks were observed in any of these members.

Photo 6: Gusset plate with missing bolt (Looking northwest from the bridge deck)

replaced with round-headed bolts. The round-headed bolts will more closely resemble the original round rivets. In some cases where the area around the existing bolt hole is badly corroded, a new bolt hole in a different location may be needed.

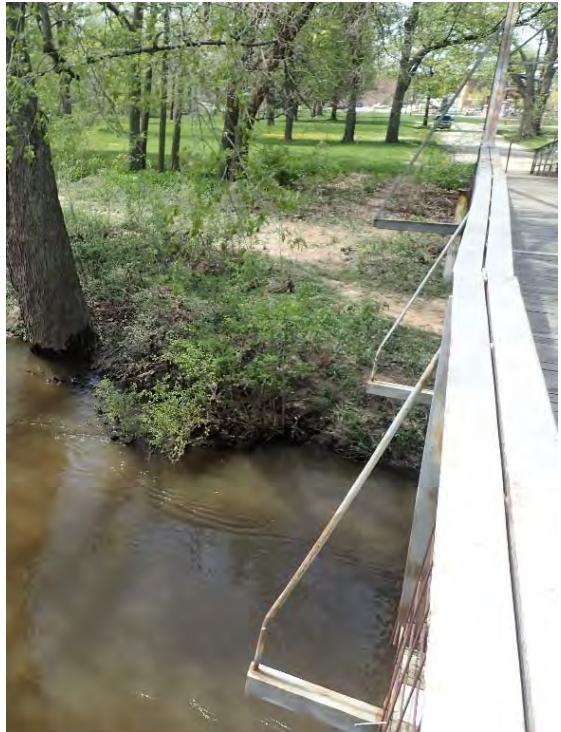
Photo 7: Lateral bracing on the south side of the bridge *(Looking west from the midspan of the bridge)*

The additional lateral bracing which has been added above the bridge deck to the sides of the structure will be removed. These are not original, and removing them will better restore the bridge to its original design. Any lateral stability that was provided by these supports will be replaced by the additional lateral support members underneath the bridge deck. Some water gauge equipment has previously been attached to the north side of the bridge. VS will coordinate with the United States Geological Survey to determine if the equipment is still in use.

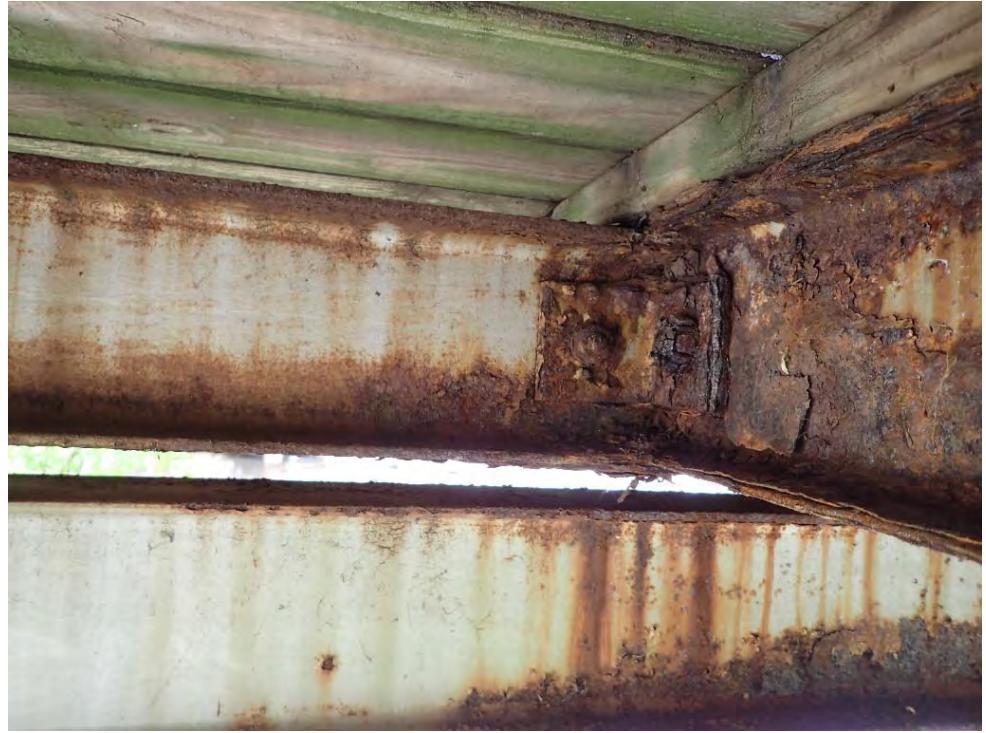
- 3. <u>Specific Deficiencies</u>.
  - The bridge experiences large lateral deflections when it is used by multiple pedestrians.
  - Many of the stringers and floorbeams show severe rust and section loss. Connections of these members are also severely rusted. (Photos 9 & 10)

Photo 9: Severely rusted floorbeam-stringer connection (Looking east from under the bridge on the west bank)

The portion of the superstructure underneath the bridge deck consists of the floorbeams, stringers, and cross-bracing. These elements appear to have been replaced before, so they are likely not historic. They are also in very poor condition, so all of the floorbeams, stringers, and cross-bracing will be replaced. The existing arrangement of the floorbeams, stringers, and cross-bracing is not very effective in providing lateral stiffness. Additional members will be added underneath the bridge deck to add lateral stiffness to the bridge. These additional members will differ from the original design of the bridge, but they will be located underneath the bridge deck and out-of-sight for most pedestrians using the bridge. After installation, all members will be cleaned and painted with the current INDOT painting system.

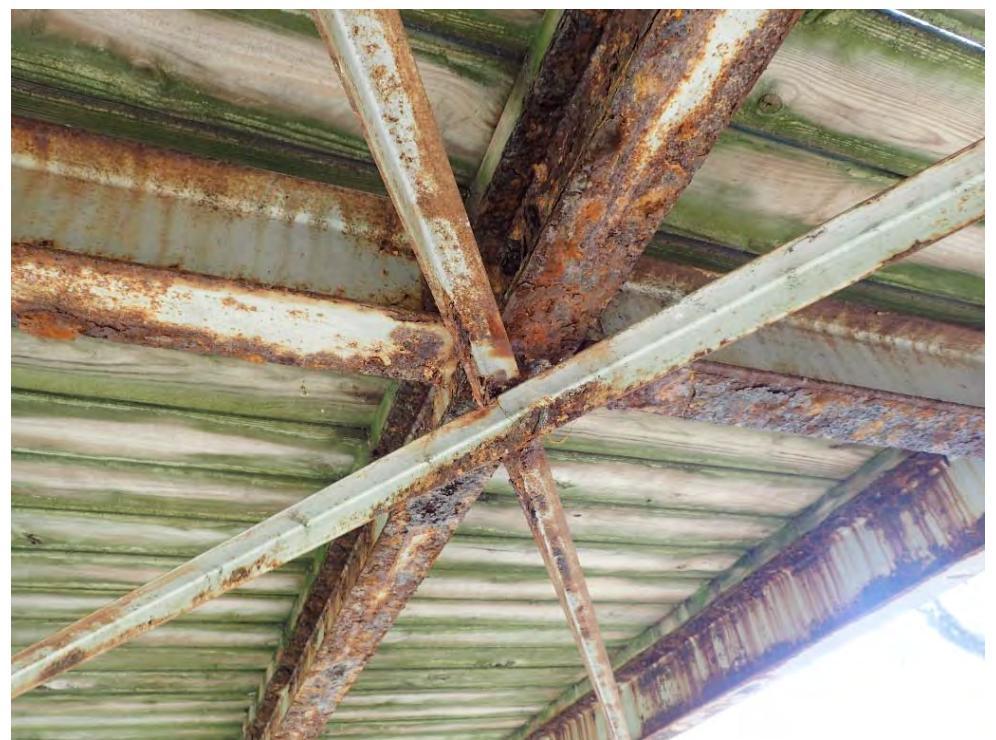
Photo 10: Severely rusted stringer and floorbeams (Looking east from under the bridge on the west bank)

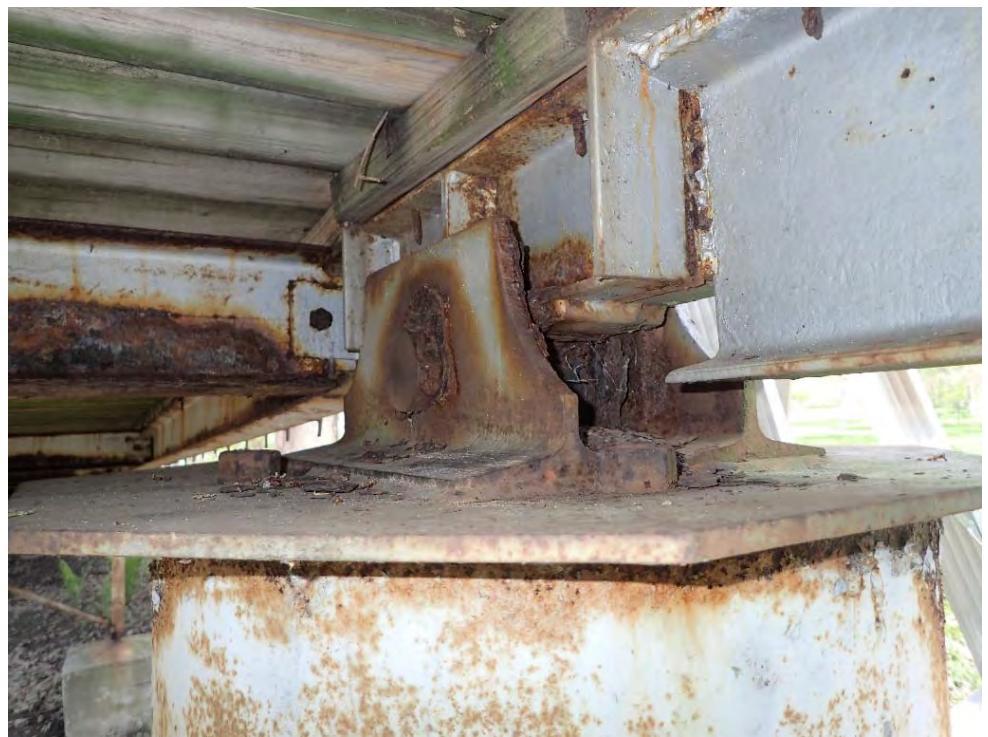
- 5. <u>Damage</u>. No damage from impacts is visible.
- 6. <u>Bearings, Pedestals</u>. The bearing pedestal and pins show significant rust, especially at the connection of the bearing pedestal to the top of the piers, and around the pin location. (Photos 11 & 12)

Photo 11: Bearing assembly at main north pier (Looking northwest from under the bridge on the west bank)

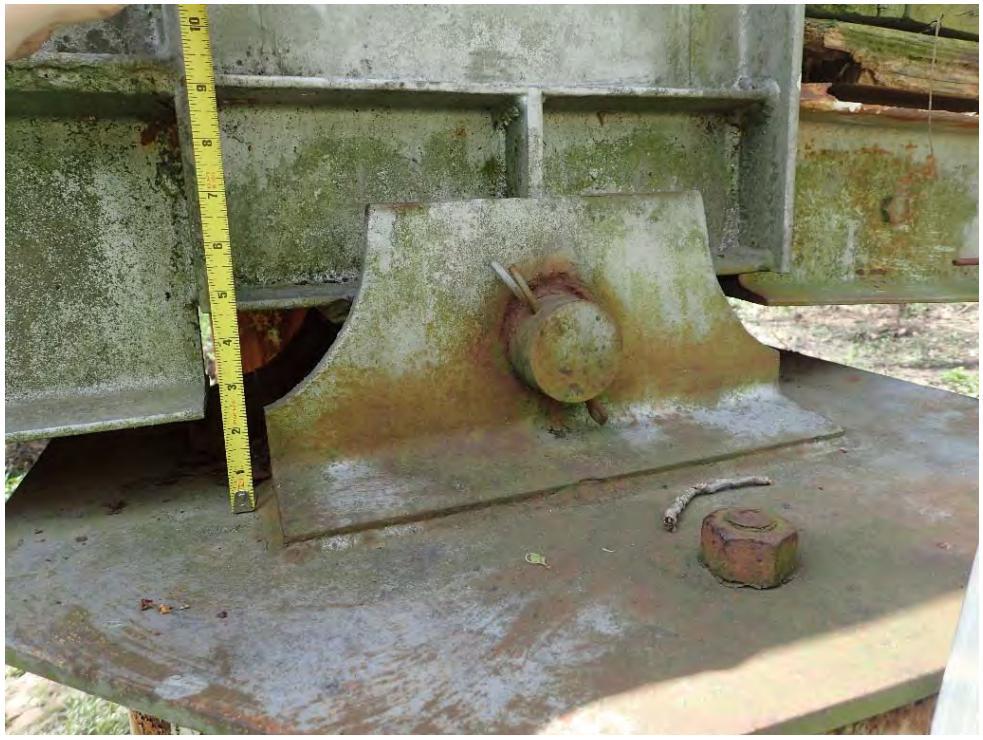
Photo 12: Bearing assembly at the main north pier *(Looking south from the west bank)*

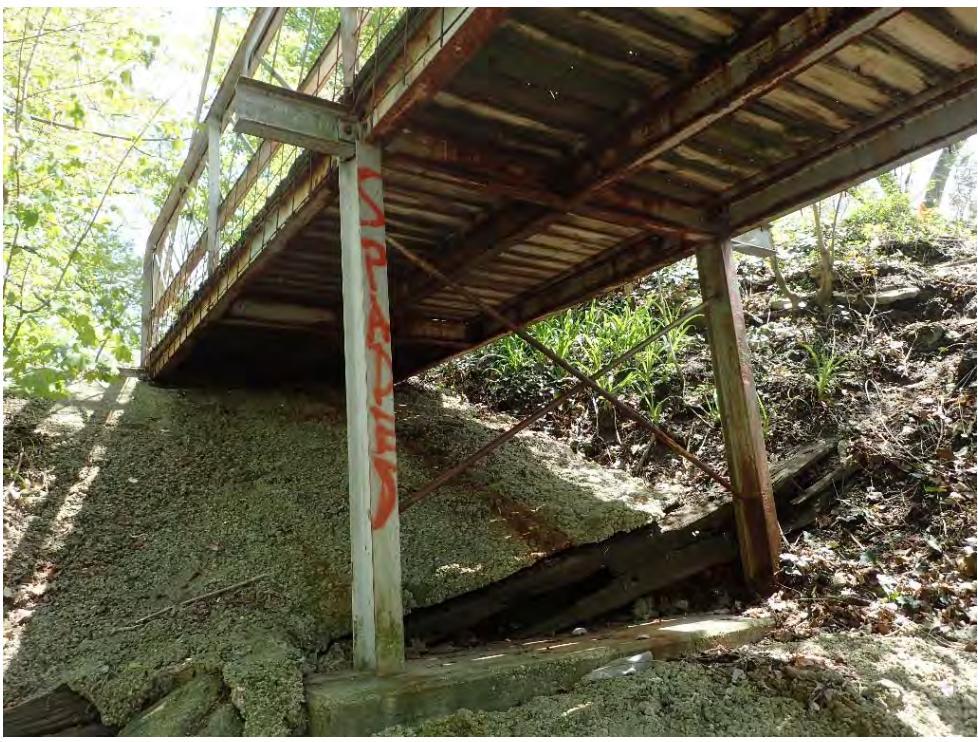
- 2. <u>Repair/Maintenance</u>. The secondary piers appear to be relatively new, and they were likely replaced. For the main piers and abutments, no repairs or maintenance are visible. (Photos 13 & 14)

Photo 13: Secondary piers at the east end of the bridge *(Looking east from under the bridge on the east bank)*

<u>Substructure and Foundation:</u> The existing abutments and piers will remain in place unless underground deterioration is found during construction. The cable anchorages will be excavated during construction to determine the integrity of the anchorage. If the anchorage appears to be unstable or deteriorating, it will be replaced with a new concrete anchorage. For all of the underground substructure elements, different repair methods will be considered before construction for some of the likely problems that the contractor may find. Also, all steel portions of the substructure will be cleaned and painted in the current INDOT painting system.

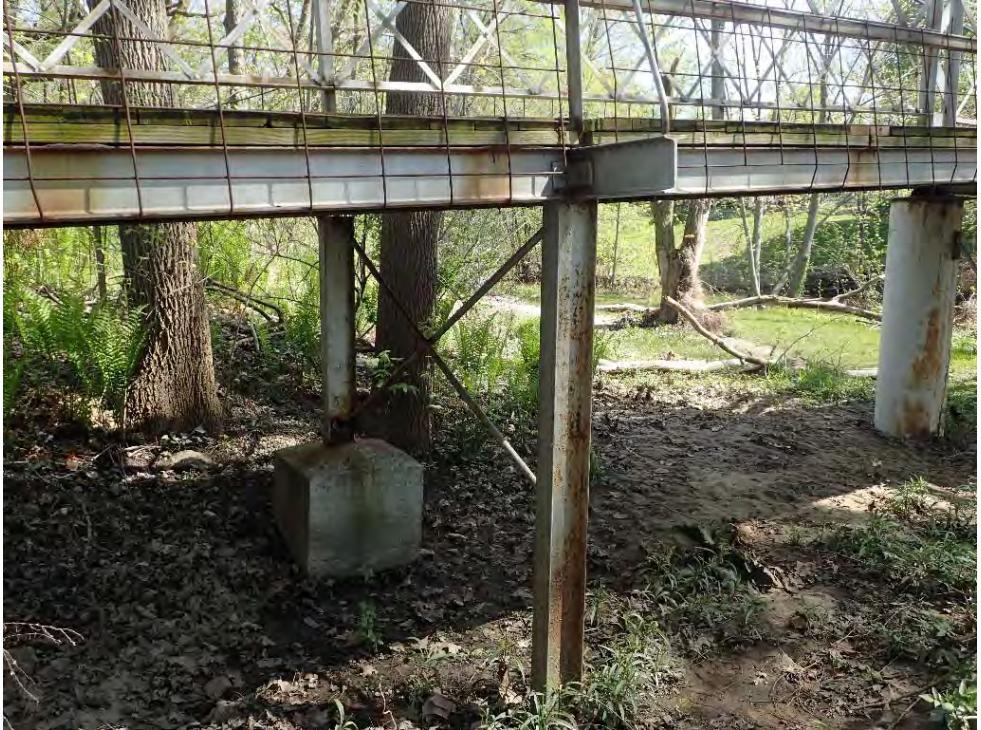
- 7. <u>Other</u>. The bottom portions of some of the steel elements are buried below grade, possibly leading to corrosion. The west abutment is exposed; however, the east abutment is completely buried under asphalt. (Photo 14)

Photo 14: Secondary piers at the west end of the bridge (Looking north from south of the bridge on the west bank)

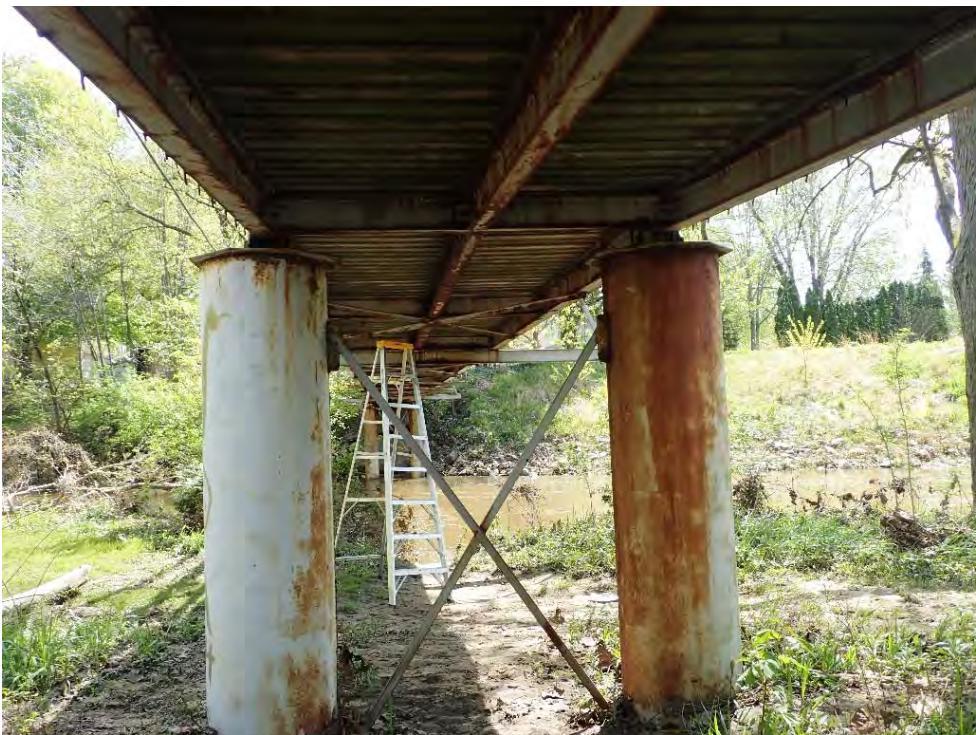
- 3. <u>Specific Deficiencies</u>. Rust is visible above grade on the steel pipes of the main piers. (Photo 15)
- 4. <u>Seismic</u>. This structure is in Seismic Zone 1.

Photo 15: Main piers at the west end of the bridge (Looking east from under the bridge on the west bank)

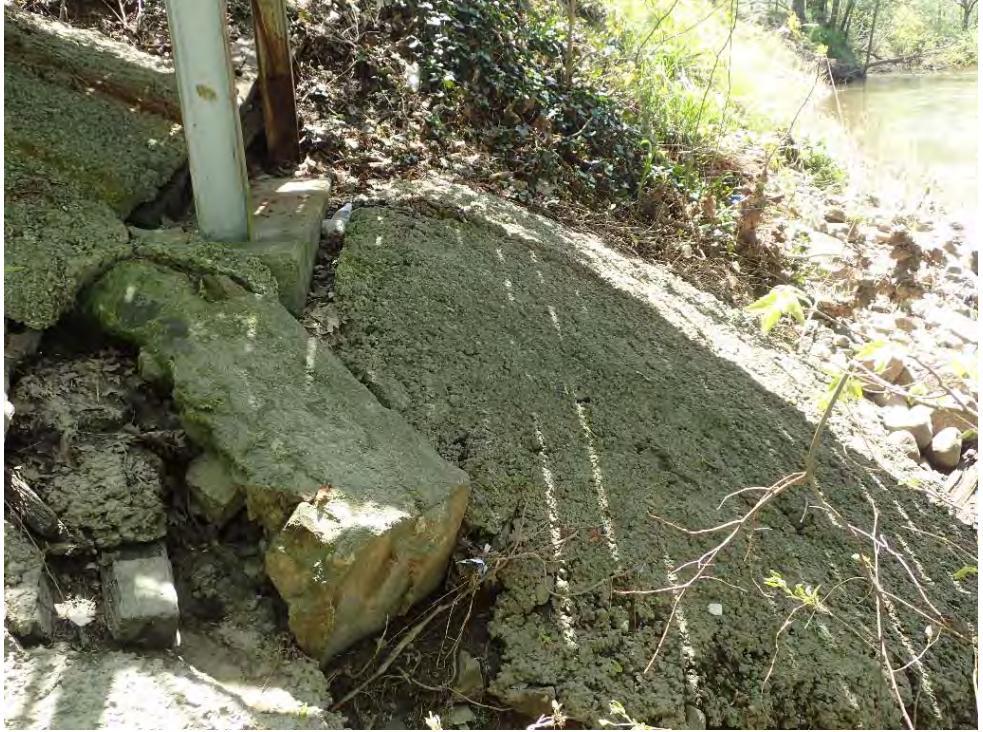
- 5. <u>Drainage</u>. Concrete has been placed on the east bank of the river, underneath the bridge, in an attempt to stop erosion. This concrete is failing and falling down the slope. Stone riprap has been placed along the east bank south of the bridge. (Photo 16)

Photo 16: Concrete slope protection on the east bank *(Looking south from the east bank)*

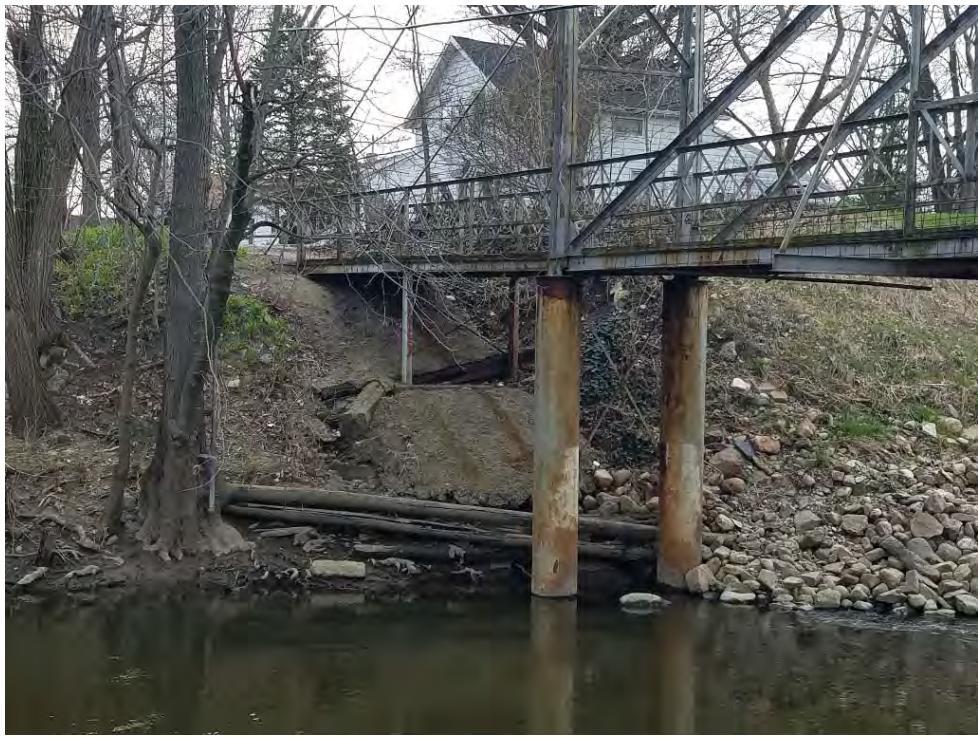
- 9. <u>Miscellaneous.</u> The approach from the road to the bridge on the east end of the bridge is not ADA compliant.
- E. <u>Slopewalls</u>. The condition of the slopewalls is fair. Concrete has been placed on the east bank of the river, underneath the bridge in an attempt to stop erosion. This concrete is failing and falling down the slope. Stone riprap has been placed along the east bank south of the bridge. Otherwise, the slopewalls are natural and do not show significant erosion. (Photo 17 & 21)

Photo 17: Substructure at the east end of the bridge *(Looking southeast from the west bank)*

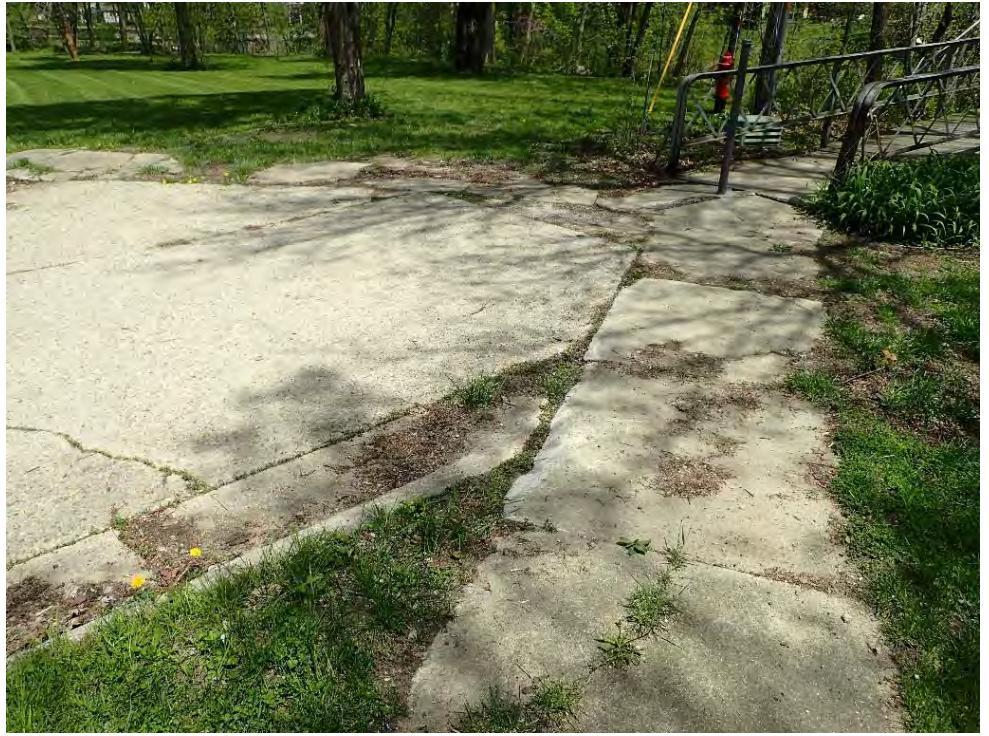
- D. <u>Approaches</u>
  - 1. <u>General</u>. The pavement on the west side of the bridge is concrete. The pavement on the east side of the bridge is asphalt. The condition of both is poor. (Photos 18 & 19)

Photo 18: Roadway and sidewalk at the west end of the bridge *(Looking northeast from southwest of the bridge)*

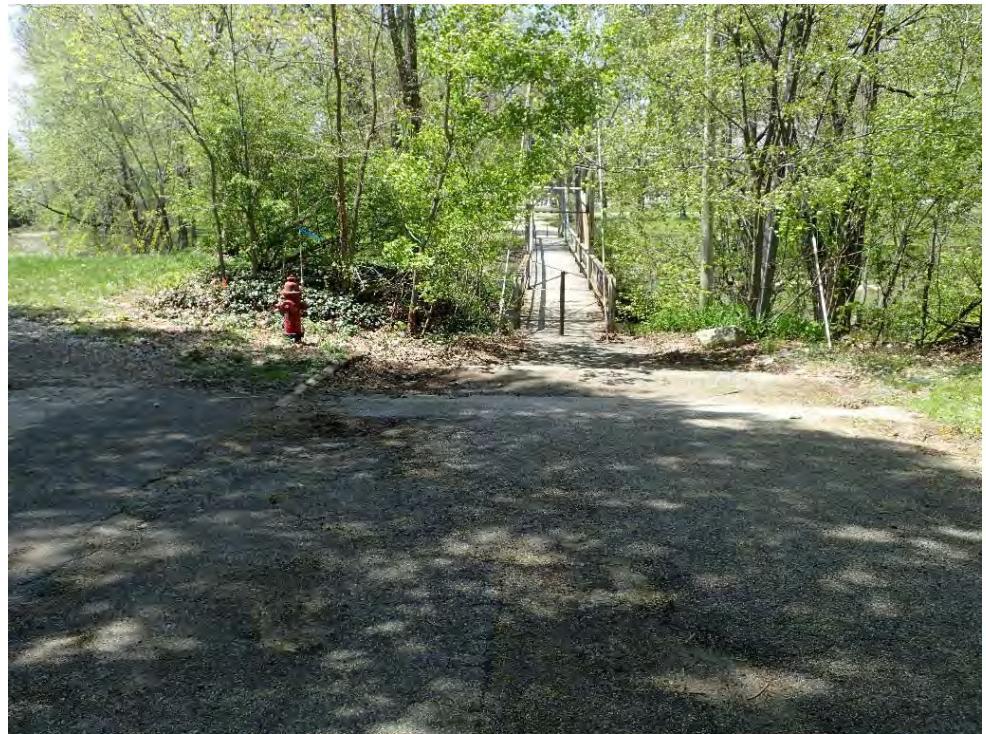
Photo 19: Roadway at the east end of the bridge (Looking west from East Laporte Street)

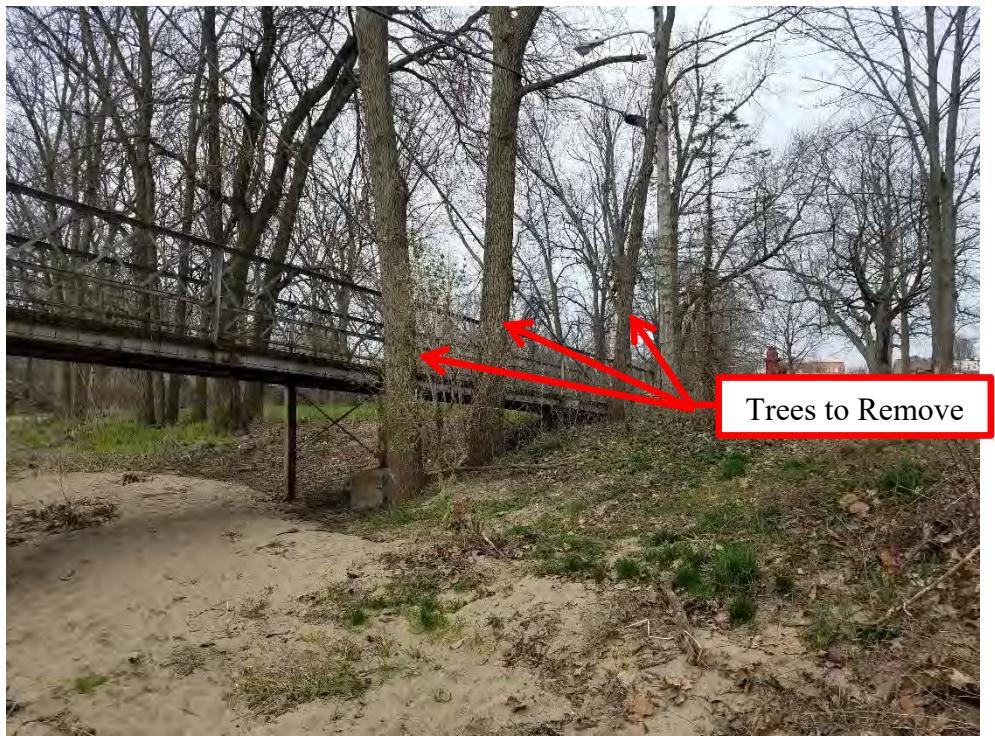
- 8. <u>Trees</u>. Trees are located on the banks immediately next to the bridge, and some of these could fall on the bridge and damage it. The shade from the trees also prevents proper drying of the bridge after a rain event, accelerating the deterioration of the structure. (Photos 21-23)

Photo 21: Trees to remove at the northwest end of the bridge. (Looking southwest from the west bank)

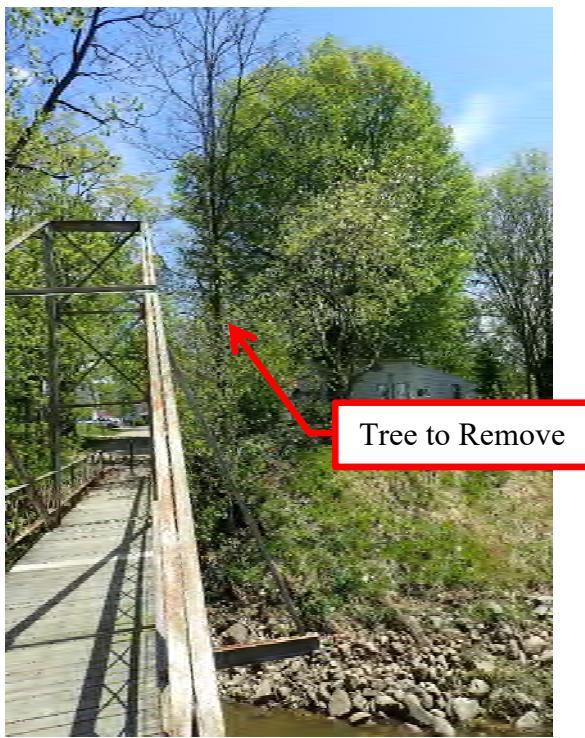
Photo 22: Tree to remove at southeast end of bridge *(Looking east from the midspan of the bridge)*

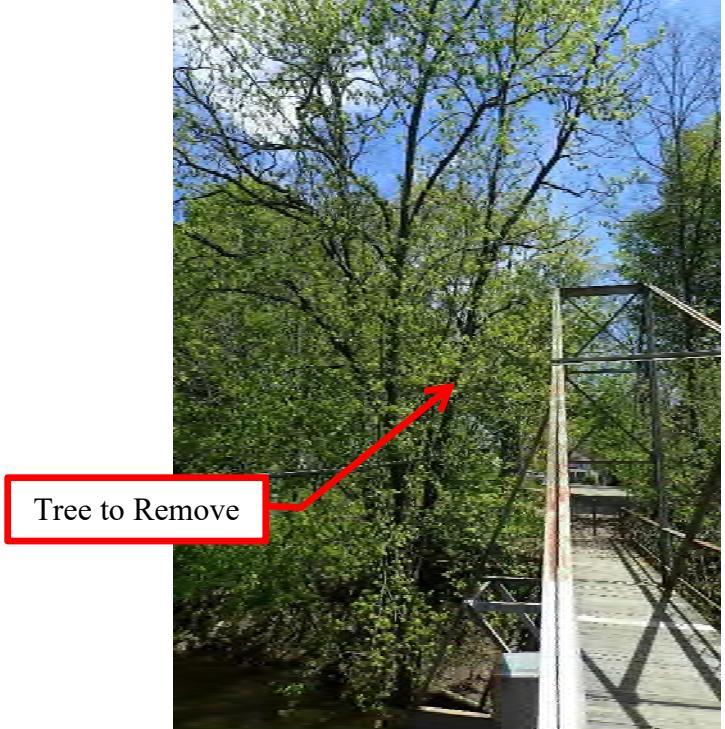
Photo 23: Tree to remove at northeast end of bridge *(Looking east from the midspan of the bridge)*

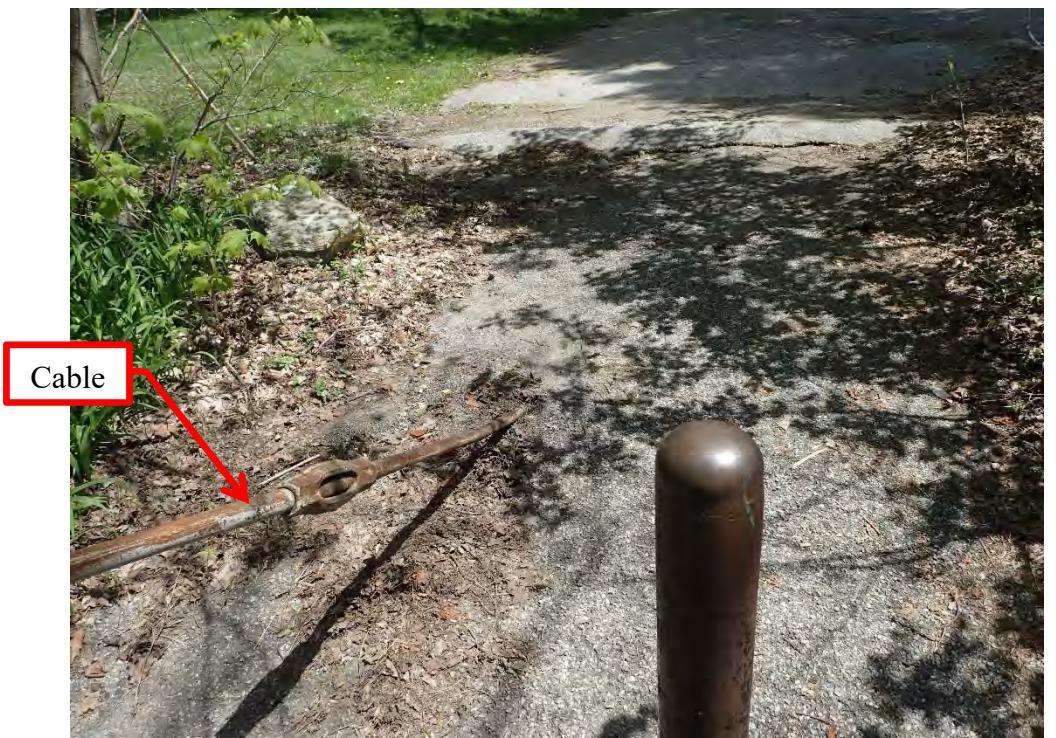
- 7. <u>Other</u>. The cables which support the bridge are relatively loose. The anchorage of these cables at the ends of the bridge extend underneath the pavement, and the condition of that anchorage is unknown. (Photo 24)

Photo 24: Cable anchorage at east end of bridge (Looking northeast from the east end of the bridge)
